UNSEALED TABS ON ASPHALT COMPOSITION SHINGLE ROOFS FOLLOWING HURRICANE IKE... IS IT WIND DAMAGE?

FUNCTION DAMAGE TO ASPHALT COMPOSITION SHINGLES

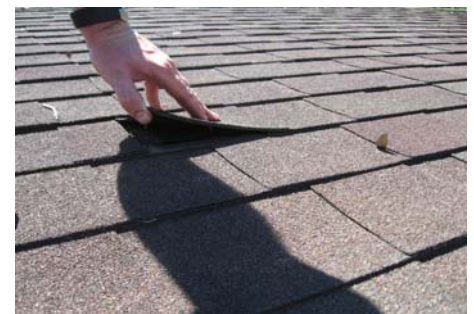
Figure 2

The application of an external force strong enough to break a sealant strip is also expected to create some fragmentation, tearing and/or creasing of the unsealed tab. An inspection of an asphalt composition single roof which reveals unsealed tabs without any evidence of fragmentation of base mat along the sealant strip (Figures 2 and 3) or tearing/creasing of unsealed shingles is again not consistent with damaged associated with high wind pressures on roof surfaces.

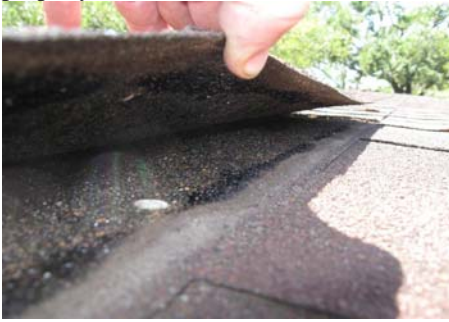
Figure 3

Exposure of the sealant strip often reveals fine particles of sands and silts adhered to the tar-based material. Reheating of the tar-based material naturally or through external means generally allows the shingle to reseal itself with the down slope shingle with no adverse effects. Generally speaking, when sealant strips loose their bond or fail to bond with the down slope shingle, it is found to be the result of an installation defect, large accumulations of debris over the life of the shingle, or simply a naturally-occurring break-down in the sealant strip over the life of the shingle.

One other common report of wind damage associated with unsealed shingle tabs is that the sealant strips have been compromised due to the exposure to wind borne debris causing the shingle to not

properly reseal.
